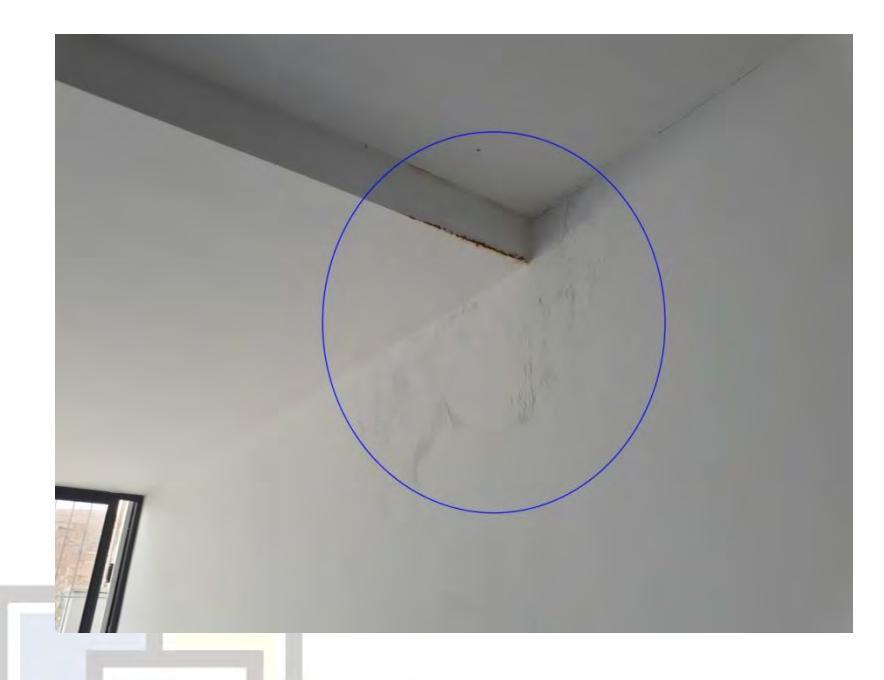
Rusty aluminium plaster corner profile & damp stains on wall and ceiling

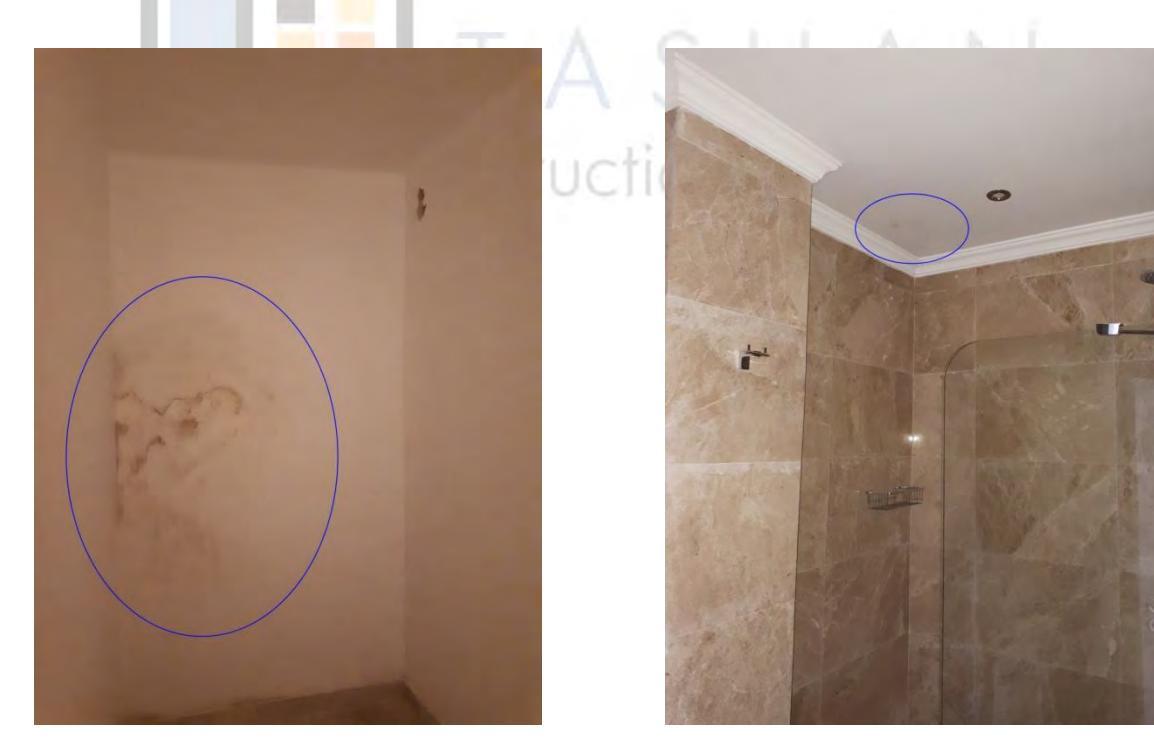
Damp stains in lower ground floor bedroom

Damp stains on suspended ceiling

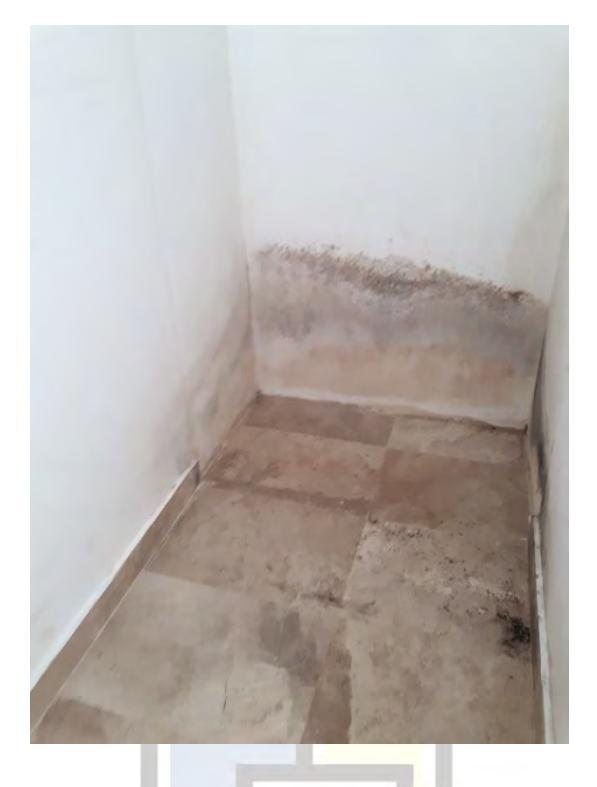
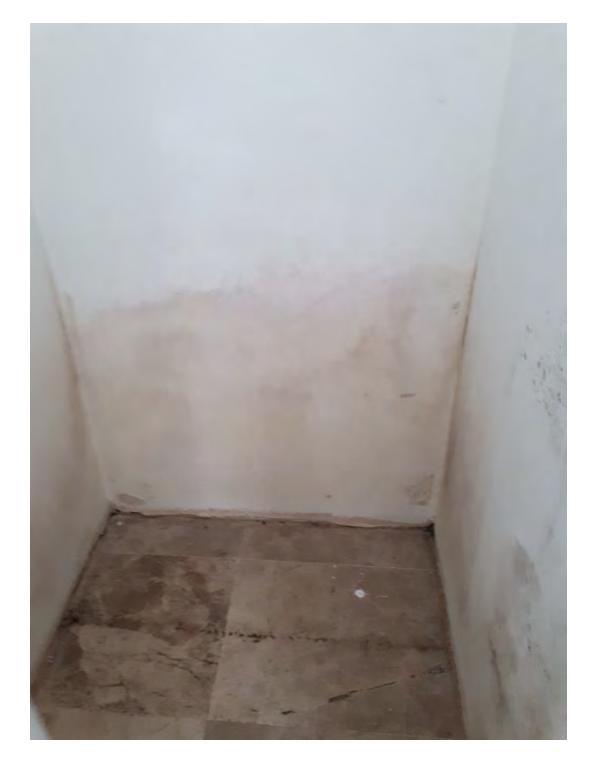
Problems reported in Bedroom 6 & 7 are mostly like to be a typical penetrating damp issue. The two main reasons for dampness in areas such like are:

In our case, it seems like the source of humidity is water from rain or ground-water but the property managers have stated that the problem occurs more effectively in hotter periods of summer. This could be a sign of exterior humid air entering in and condensing on cooler surfaces causing moisture.

Poor condition of walls behind fitted cupbords in Bedroom 6 & 7

- 1. Applying water repellents on existing walls where the cupboards are placed.
- 2. Building a cavity wall with proper insulation using mineral wool.
- 3. Creating a crawl space through the suspended ceilings and a ventilation shaft on side wall as shown on the diagram. Installing a continiously operating fan to extract humid air if necessery.

4. Building ventilation shafts over the sliding doors but this should be done with combination of installing portable dehumidifiers in each room. Same as the lower ground floor, ideal way to deal with the problem is to install a ducted system as shown on the diagram below.

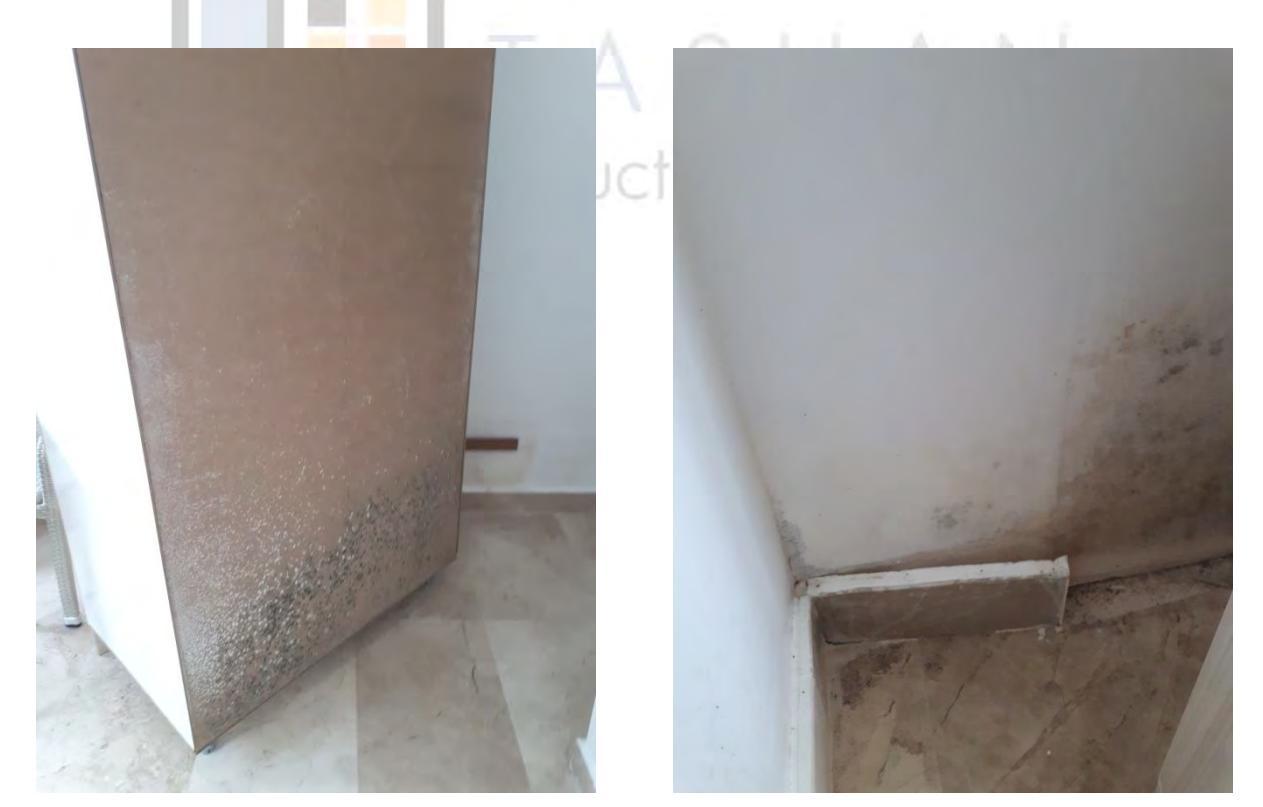
Defective backing board due to mold & mildew Mold behind bed headboard Kalkan Mah. Lale Sok. No:6/C 07960 Kaş / Antalya – TURKEY Tel/Fax : +90 242 844 1355 / Mobile : +90 532 425 0934 info@kalkanredesign.com www.kalkanredesign.com
