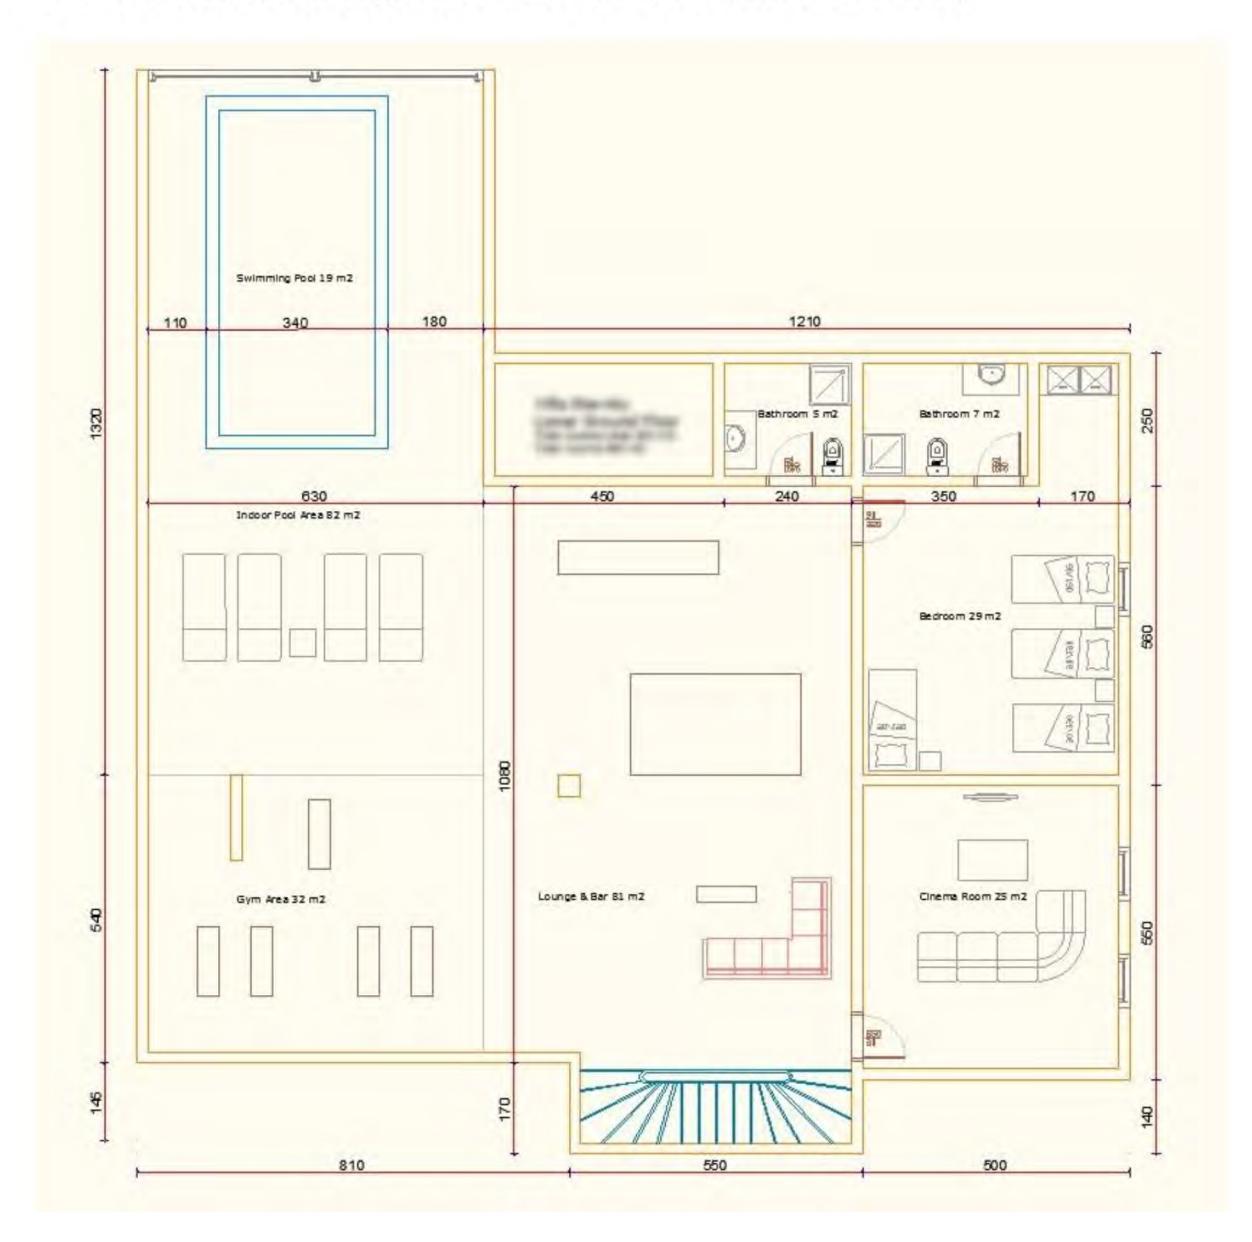
C1 Lower Ground Floor (app. 300 m² of covered space & 850 m³ of volume)

It has been inspected that total covered space of m² in lower ground floor is not designed with enough and proper sized doors and window frames. It is obvious that the lack of fresh air flow is a remarkable reason of the humidity problem and not the only one. The structure is completed without consideration for controlling humidity by technical devices, ductwork systems, vapor barrier, negative pressure and mechanical space to name a few.

Indoor pool area is degined with a thought of *'it's just another room'* which is an effective reason of the mentioned problem. It is surrounded by floor-to-ceiling glass panels which is a clear sign of no vapor barriers installed to keep the moisture and vapors from the rest of the lower ground floor. The property has suspended ceilings all over the lower ground floor including the indoor pool area. It is generally accepted that suspended ceilings in swimming pool areas are a typical call for trouble. Moisture can move into the dead air space above the ceiling and proceed to disrupt the structure area above. It can also jump to other areas of the building. Therefore, any potential dead air space areas must be considered part of the overall environment and must be designed to remove the humidity. When a suspended ceiling is in place, it is recommended to ventilate with pool room air and ensure it is insulated above it.

Without further attention, it will cause accelerated oxidation on the metal surfaces, creating rust stains on reinforcing bars in far future. In close term, it will cause warping, rot, mold, mildew, rust or simply saturate the material until it loses its integrity which some of these problems have already been reported by the property managers.

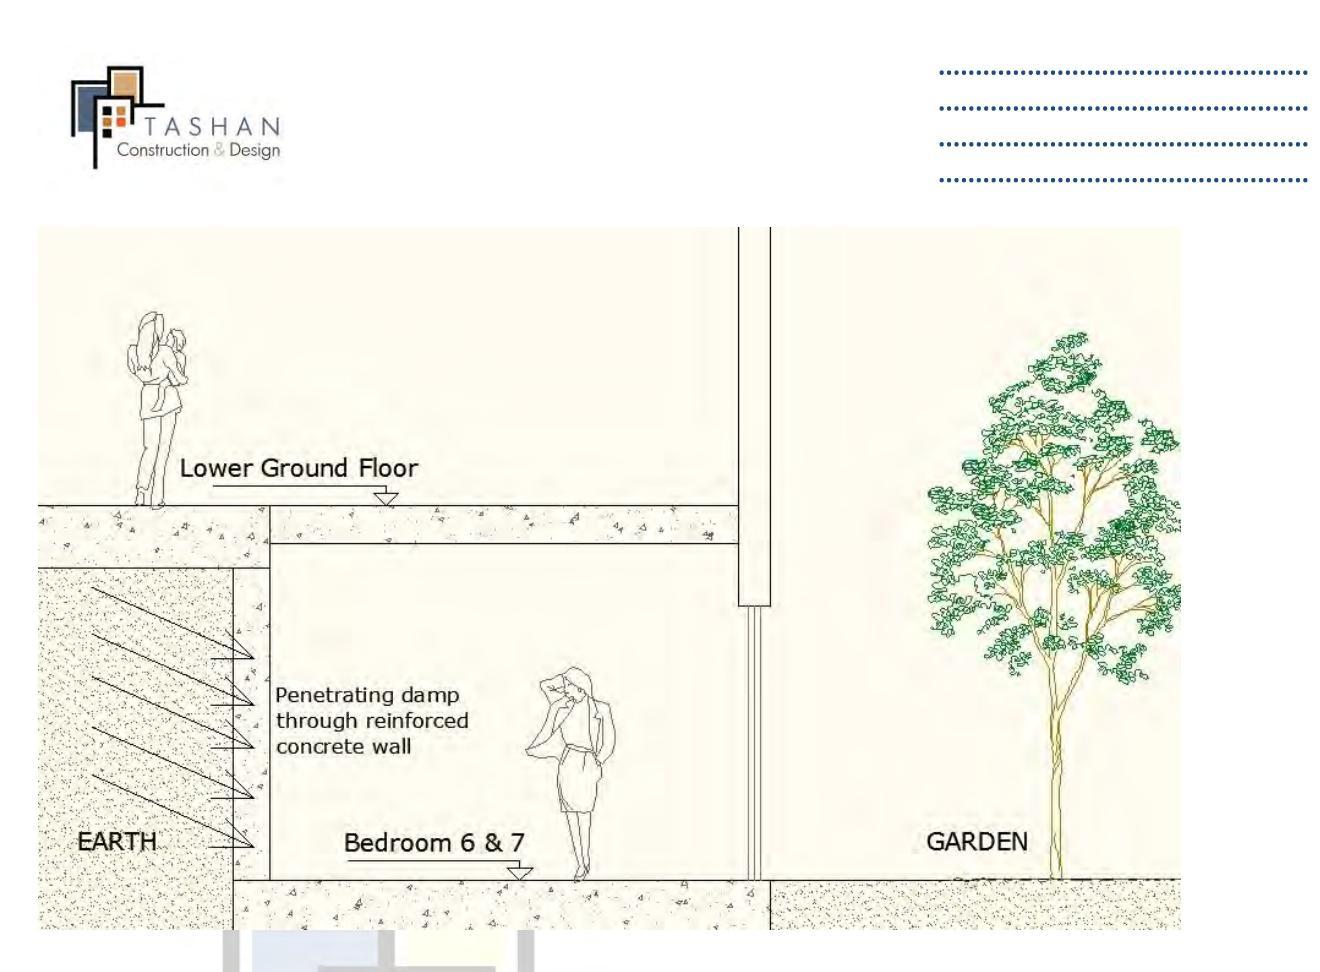
Without having visual data such as photographs taken at the construction stage, it is not possible to know what insulation methods and materials have been used to protect the reinforced concrete wall from damp and ground-water. It is also not known if there's a proper drainage system has been installed to discharge ground-water or/and rain water to avoid humidity problems.

In our case, it seems like the source of humidity is water from rain or ground-water but the property managers have stated that the problem occurs more effectively in hotter periods of summer. This could be a sign of exterior humid air entering in and condensing on cooler surfaces causing moisture.

- 1. Applying water repellents on existing walls where the cupboards are placed.
- 2. Building a cavity wall with proper insulation using mineral wool.
- 3. Creating a crawl space through the suspended ceilings and a ventilation shaft on side wall as shown on the diagram. Installing a continiously operating fan to extract humid air if necessery.
